FATIGUE BEHAVIOUR OF A ROLLED AZ31 MAGNESIUM ALLOYS PREPARED BY EP AND BB CONDITIONS

Y. Fouad

Faculty of Engineering and Materials Science, German University in Cairo, Cairo.

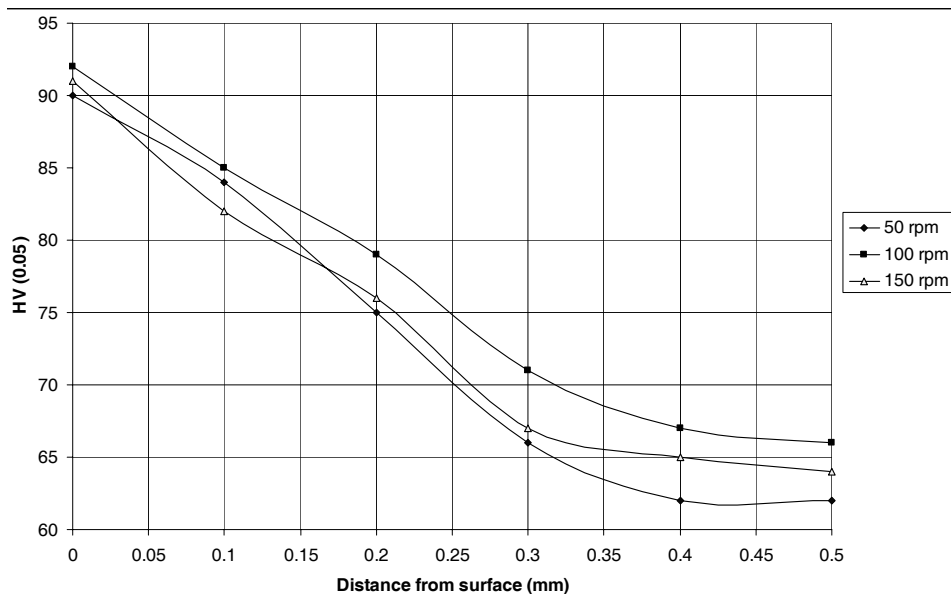
3. 3. A different experiment were used to investigate the best condition for BB (pressure, feed rate, speed) as example for tool HG3 200 bar (123 N) for 50, 100 and 150 rpm. The microhardness measurement from the surface in Fig. 3. Shows that the suitable condition for using 200 bars is 100 rpm for AZ31 as the hardness decreased from the circumference gradually to the center.

Fig. 3. Microhardness profile of AZ31 after BB at 200 bars, 0.17 mm/min at different BB rotation speed.

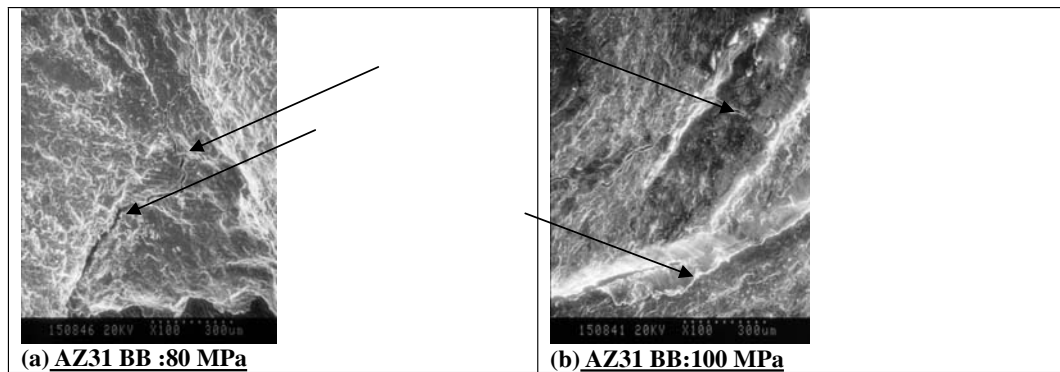
Fig. 5. SEM micrographs showing cracked surfaces at difference stress for BB at (a) 80MPa; (b) 100 MPa

The cracked line could be seen easily for higher stress for BB condition as fracture occurs in internal surface not at the outer surface as in the EP condition in Fig. 5.
